AE REDEVELOPMENT

Asbestos Survey and Report

**West Lafayette City Hall
609 W Navajo Street
West Lafayette, IN 47906**

August 30, 2016

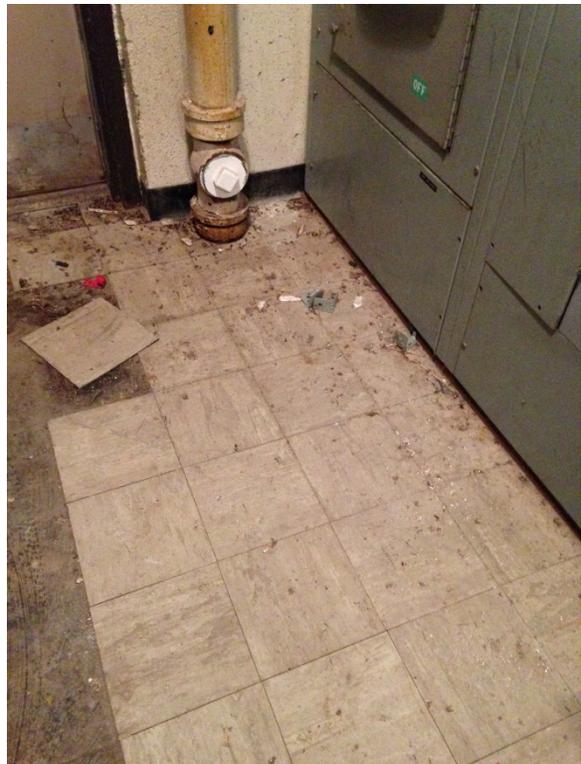
HA #15 – Floor Tile 02

9	Ceiling tile - 4' x 2' off white textured, no holes	CT03	102, 115, 130, 204, 302	ND	-	F	Non-ACM	4,552	SF	Good	-	-
10	Ceiling tile - 4' x 2' off white w/ worm tracks & pinpricks	CT04	217, 211, 305, 326, 327	ND	-	F	Non-ACM	4,553	SF	Good	-	-
11	Drywall - off white w/ brown speckles, orange peel texture	DW01	106, 212 (x2)	ND	-	NF	Non-ACM	522	SF	Good	-	-
12	Drywall - off white w/ smooth texture	DW02	112, 115, 202, 205, 222, 329, 305	ND	-	NF	Non-ACM	31,199	SF	Good	-	-
13	Drywall - beige raw	DW03	118, 294, 308, 309 (x2)	ND	-	NF	Non-ACM	2,866	SF	Good	-	-
14	Floor tile - 12" x 12" speckled cream	FT01	102, 109, 112, 136, 303	ND	-	NF	Non-ACM	2,216	SF	Good	-	-
15	Floor tile - 9" x 9" beige bark	FT02	103, 107, 322, 331, 332	6%	Chrysotile	NF	ACM	2,774	SF	Damaged	Remove prior to demolition	Class II

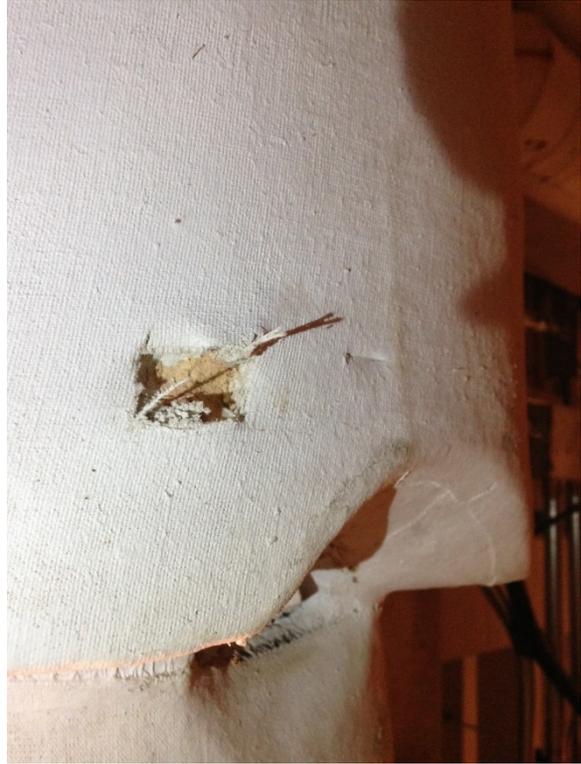
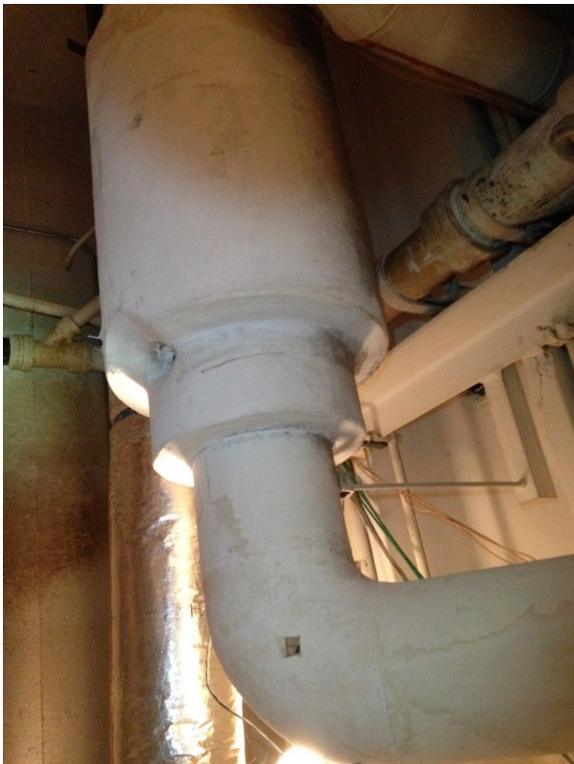
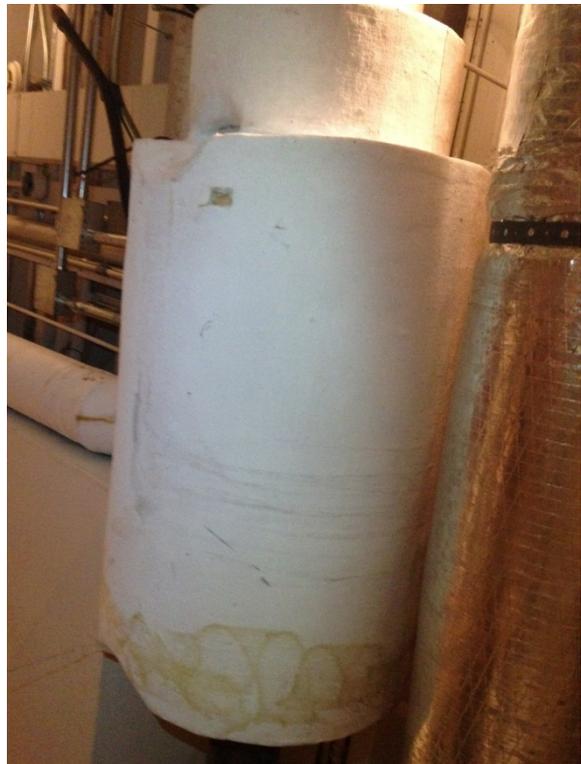
HA #22 – Thermal Insulation 04

The TSI has the highest asbestos content (15%) of the ACMs and is friable. This has the potential to present a significant health hazard to anyone entering the building. Thus, once abatement work has started, access to the building must be limited to licensed abatement workers in proper protective equipment only.

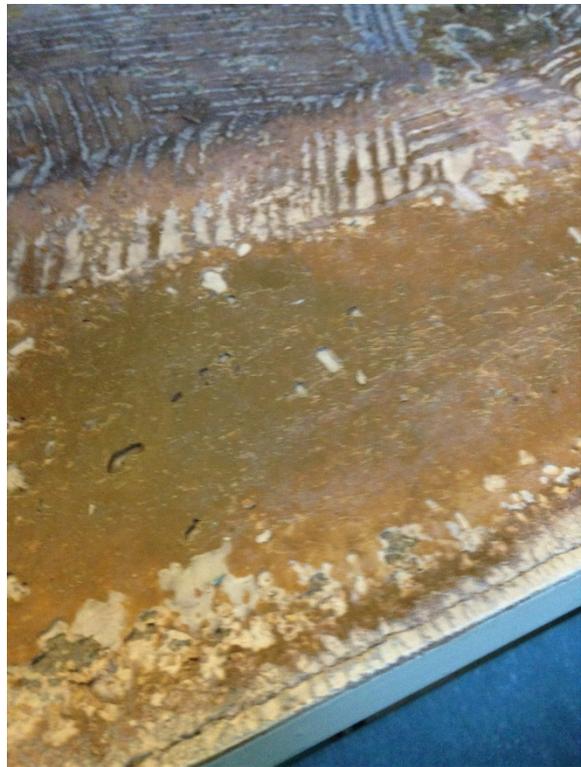
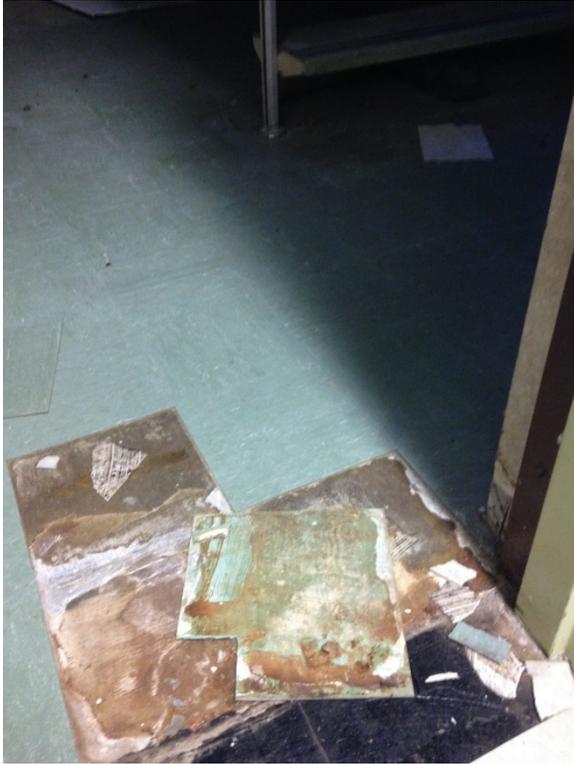
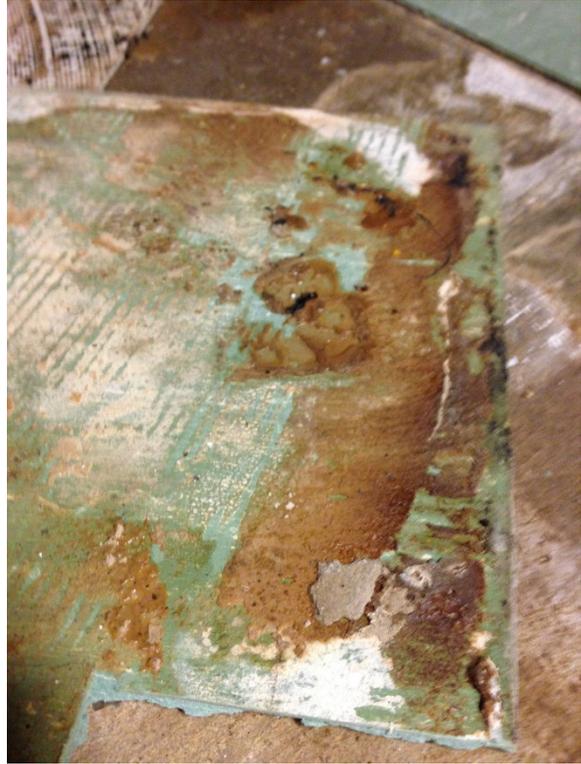
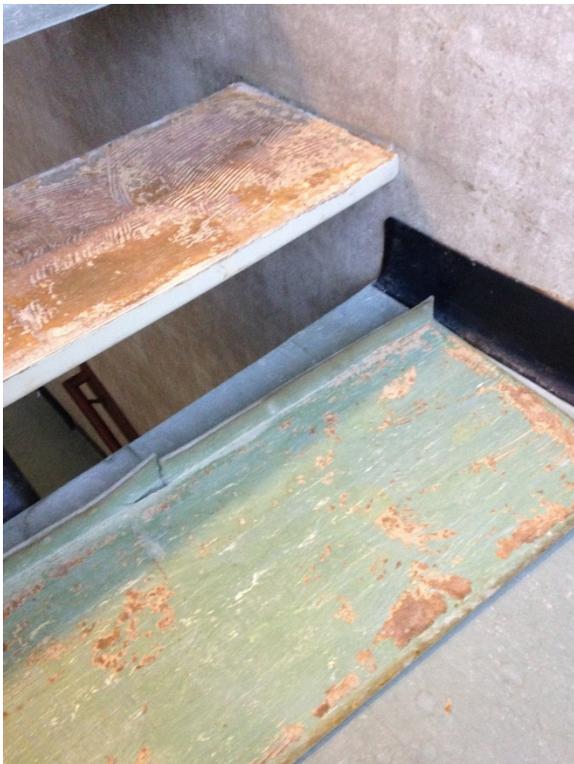
HA #26 – Tile Mastic 02

themselves tested negative for ACM; however, since the associated mastic tested positive, they will have to be abated prior to demolition.

26	Tile mastic - brownish-yellow	TM02	108, 213, 223, 313, 323	5%	Chrysotile	NF	ACM	1,116	SF	Good	Remove prior to demolition	Class II
27	Tile mastic - yellowish-white	TM03	102, 111, 130, 135, 303	ND	-	NF	Non-ACM	2,216	SF	Good	-	-
28	Wallpaper - cream, small grid texture	WP01	107, 108, 127, 211, 213, 214, 303	ND	-	NF	Non-ACM	12,040	SF	Good	-	-
29	Wallpaper - light grey squares	WP02	118 (x3), 313 (x2), 323 (x2)	ND	-	NF	Non-ACM	6,090	SF	Good	-	-
30	Wallpaper - green, orange peel texture	WP03	207 (x2), 223 (x3)	ND	-	NF	Non-ACM	2,324	SF	Good	-	-
