Section #1: Window Replacement

Window Replacement Schedule

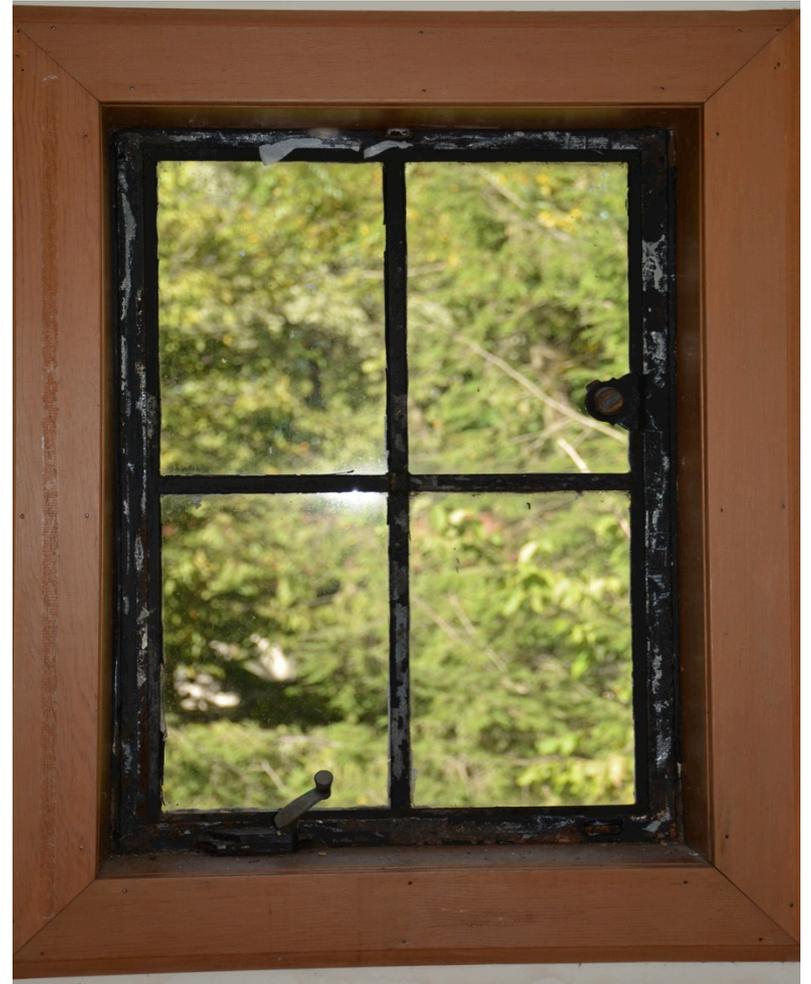
Window #1

See Detail & also note condition of window due to condensation and plastic remnants to try to prevent heat loss

1&3- Existing Steel Window visible by public right of way- to be replaced by Pella Architect Casement 19x26

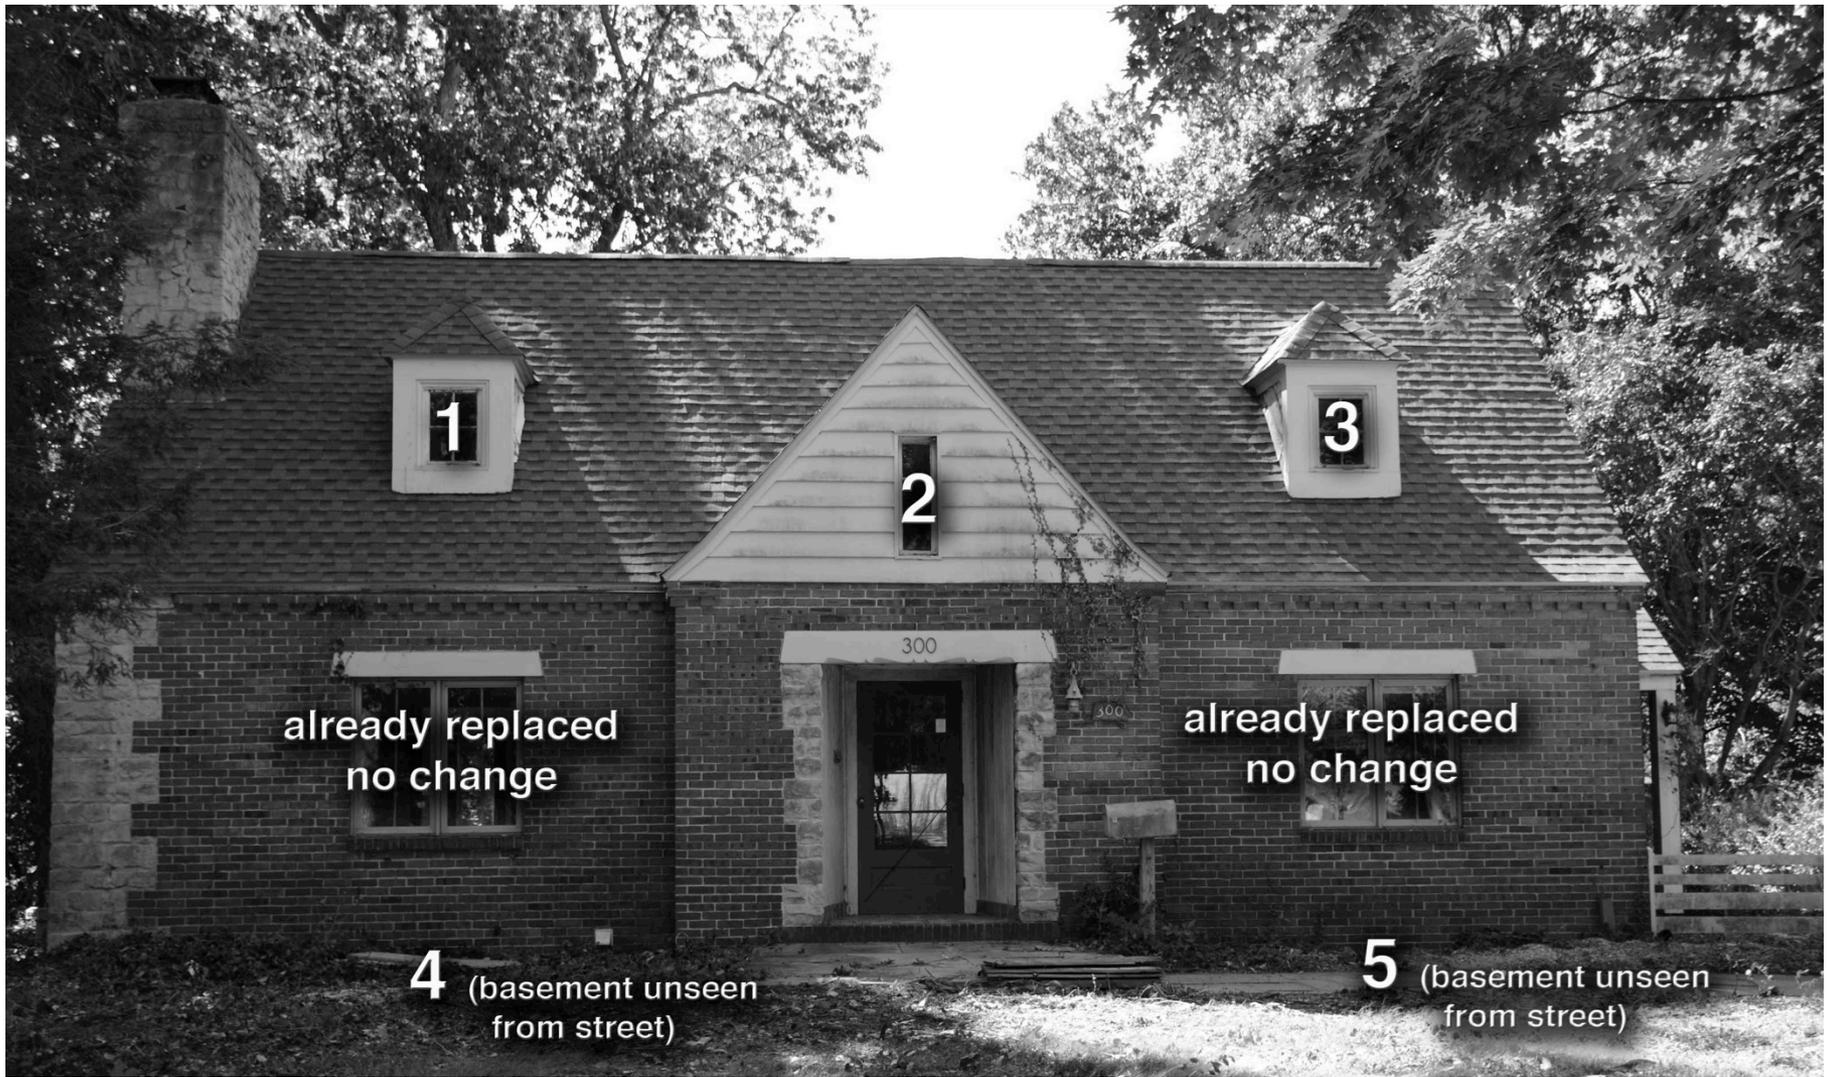
North Elevation

1
already replaced
no change

4 (basement unseen
from street)

5 (basement unseen
from street)

Visible by public access

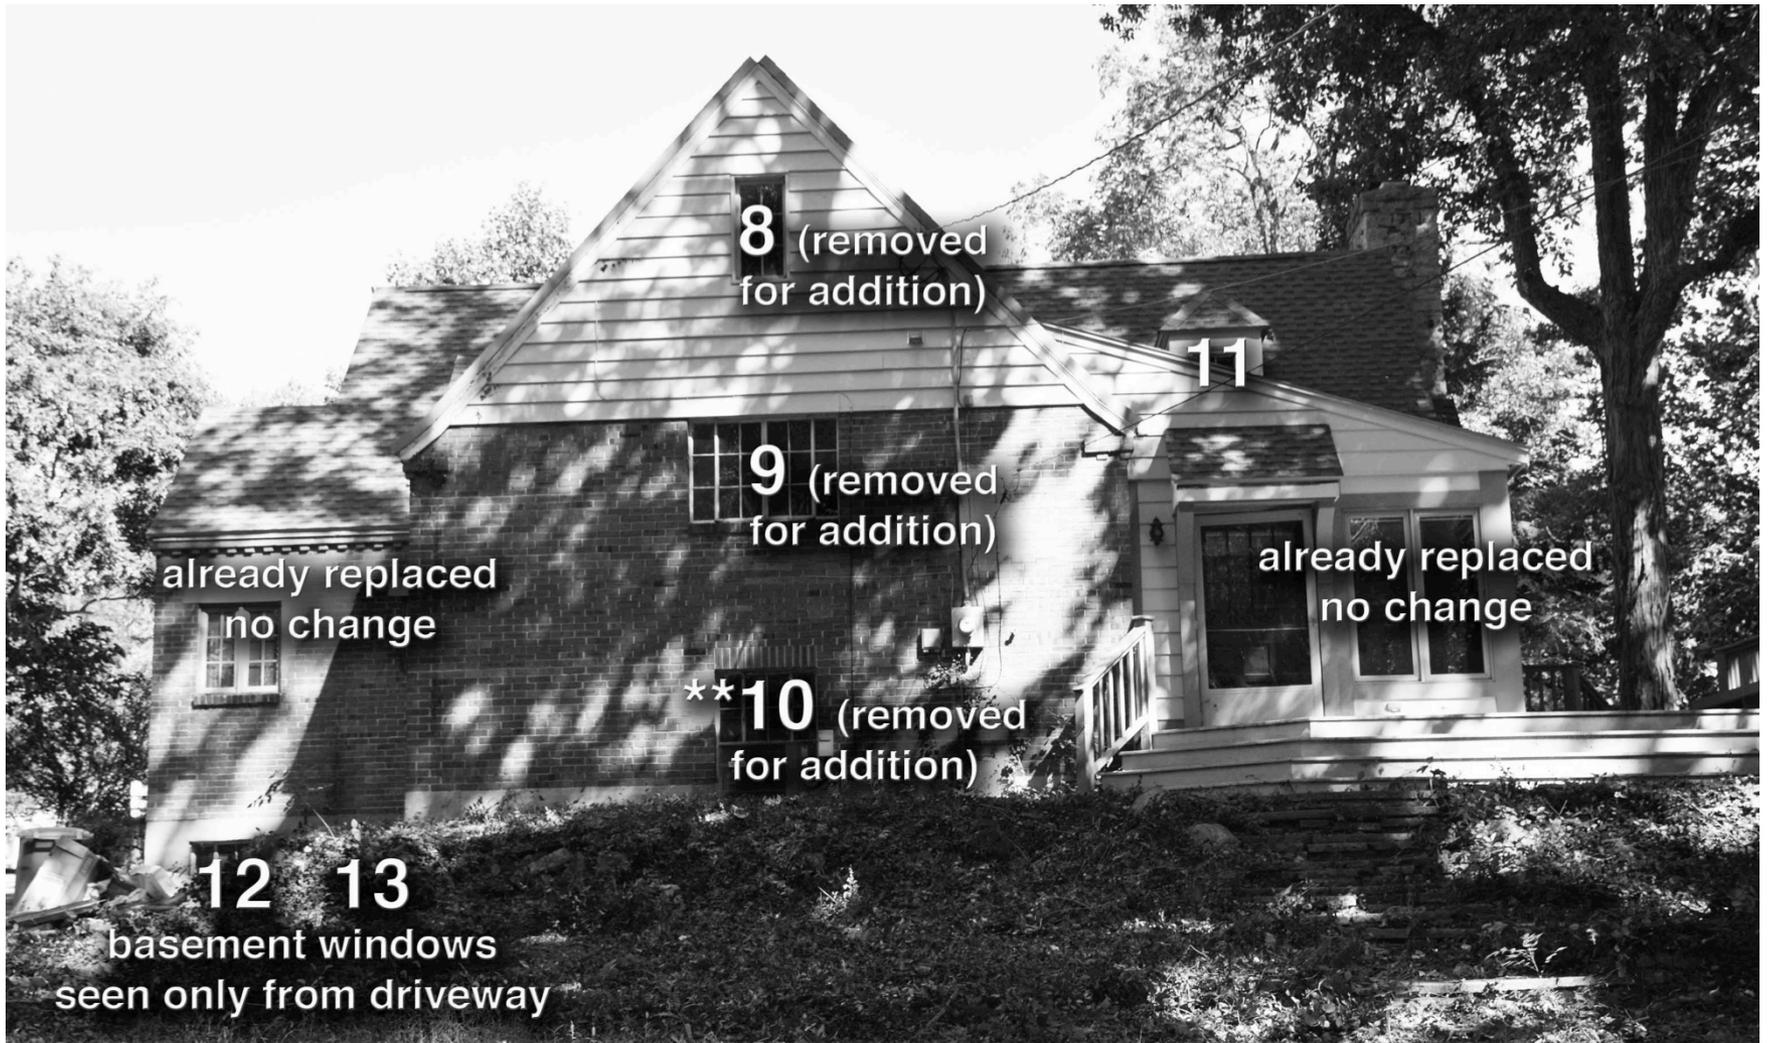
South Elevation

8 (removed
for addition)

9 (removed
for addition)

**10 (removed
for addition)

12 13
basement windows
seen only from driveway

Not visible by public access

8,9,10 to be removed for access into the addition

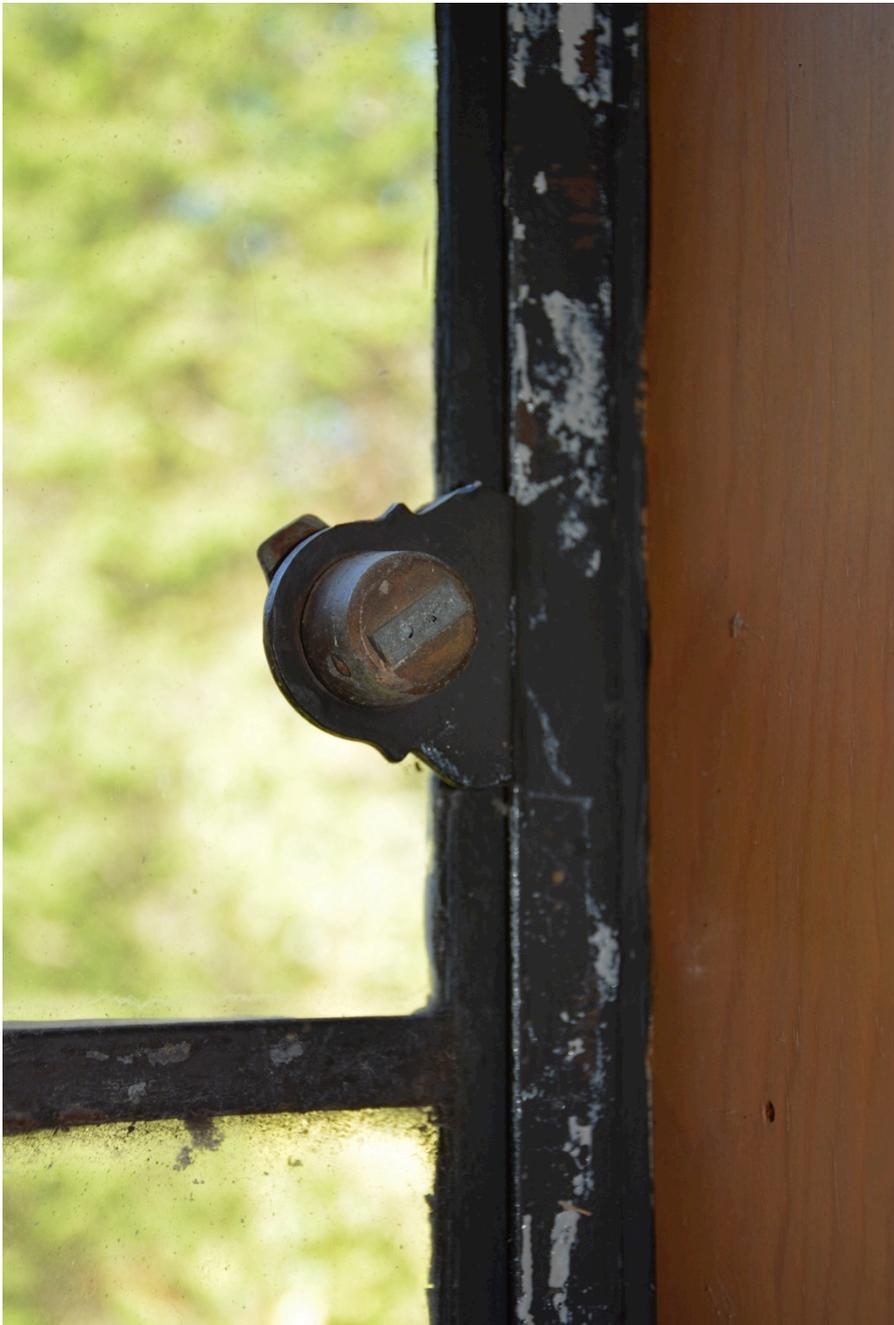
Window #1

Detail-
broken lock,
peeling paint,
rust, no screen
etc.

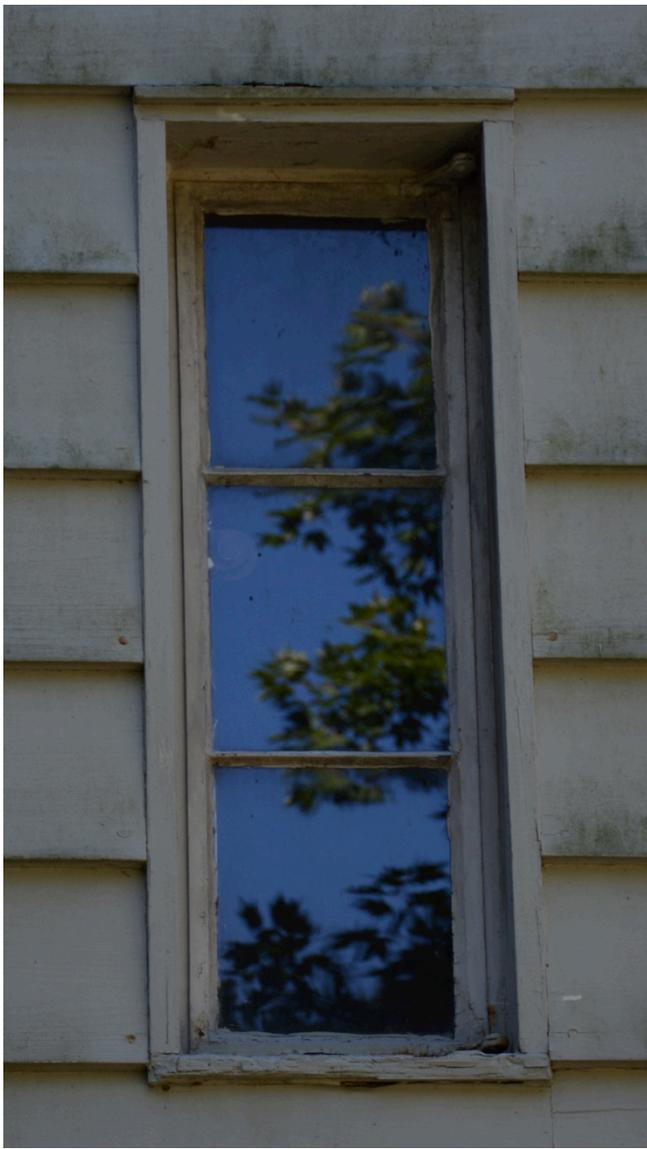
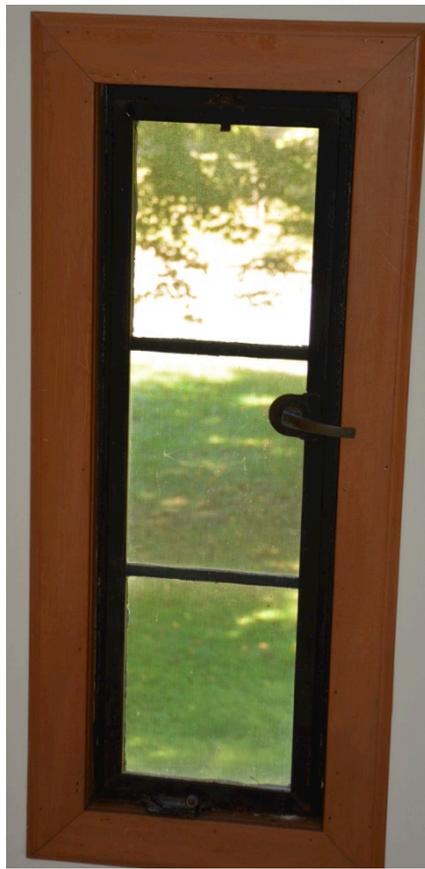
Window #2

Detail below-
rust, missing
crank,
deterioration

2-Existing Steel Window visible by public right of way – to be replaced by Pella Support Product, Direct set Fixed Frame, 12.5x38.25

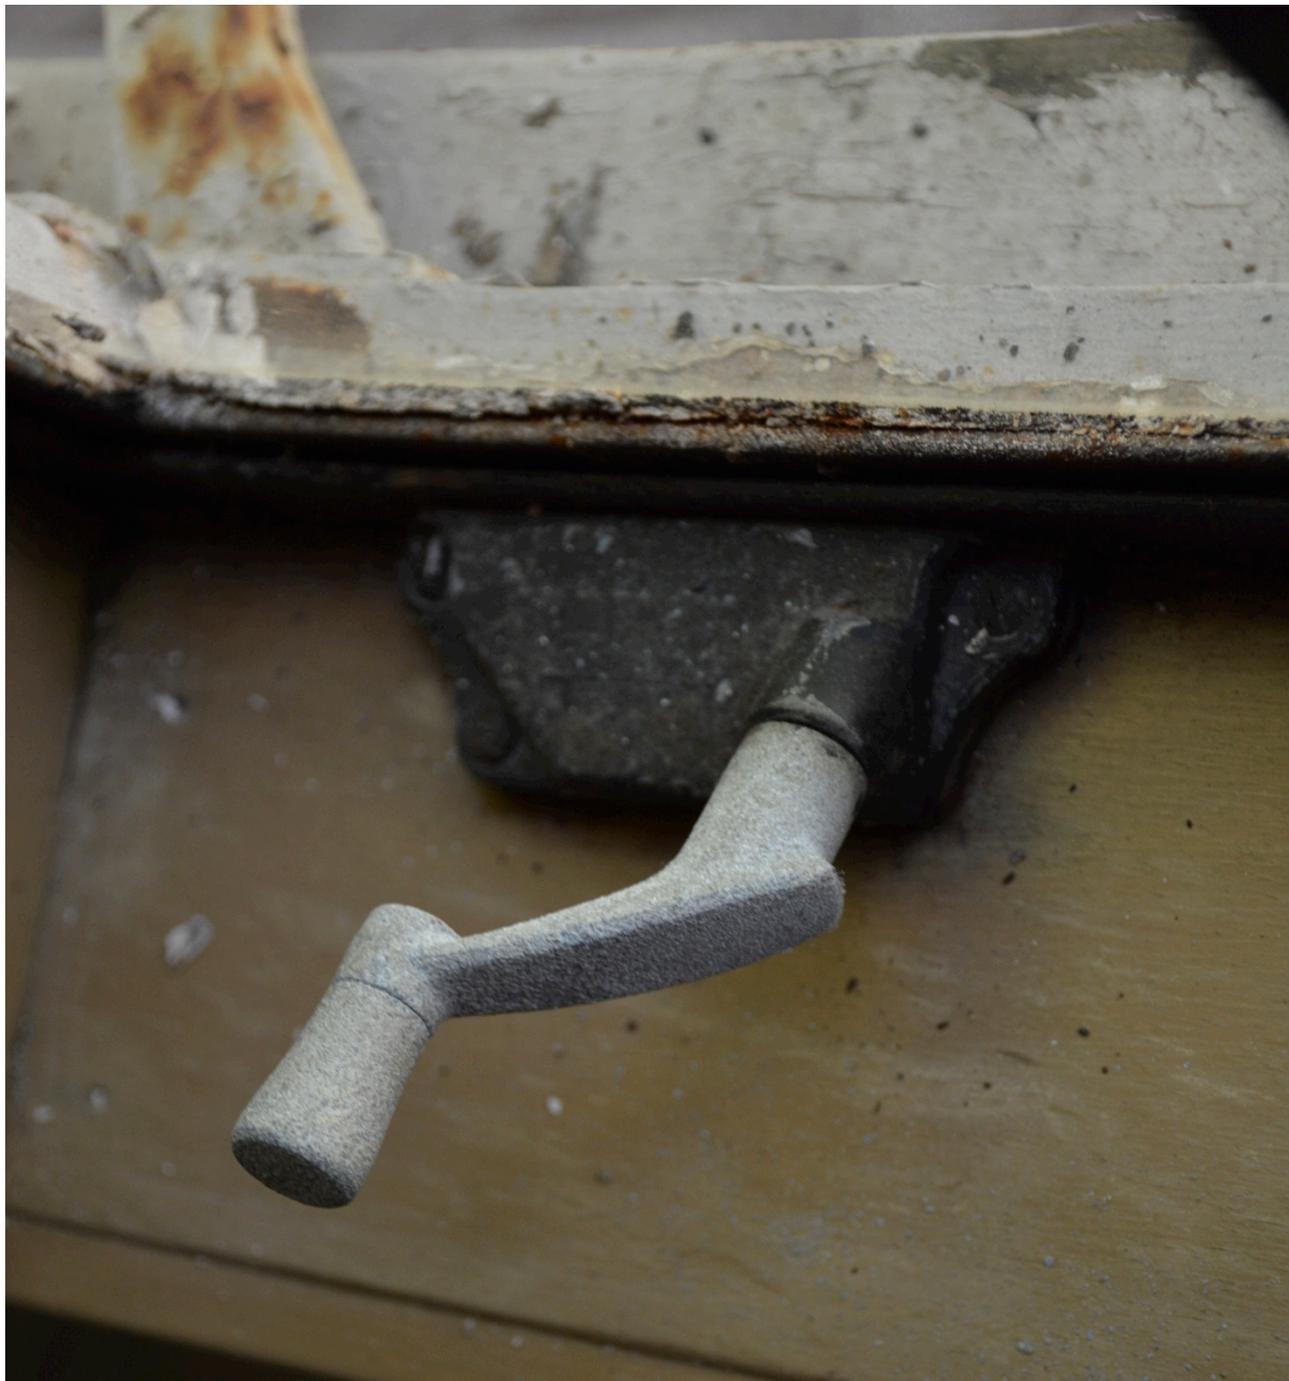
Window #3

Detail-
extensive rust
& deterioration,
also of note,
there is no
room to install
storm window

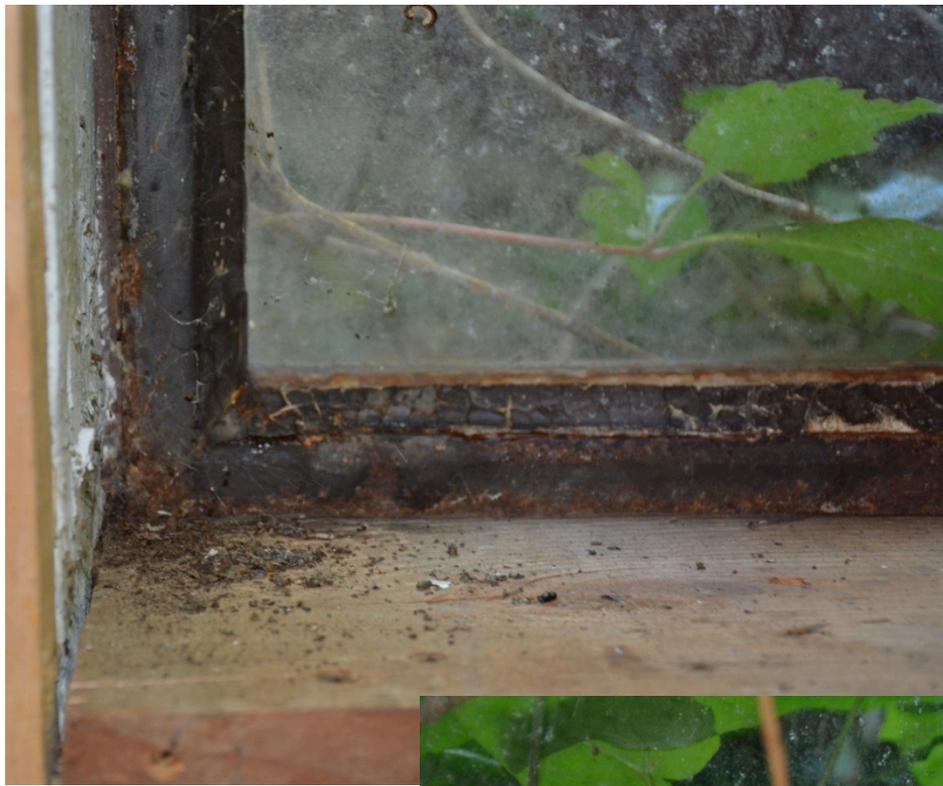
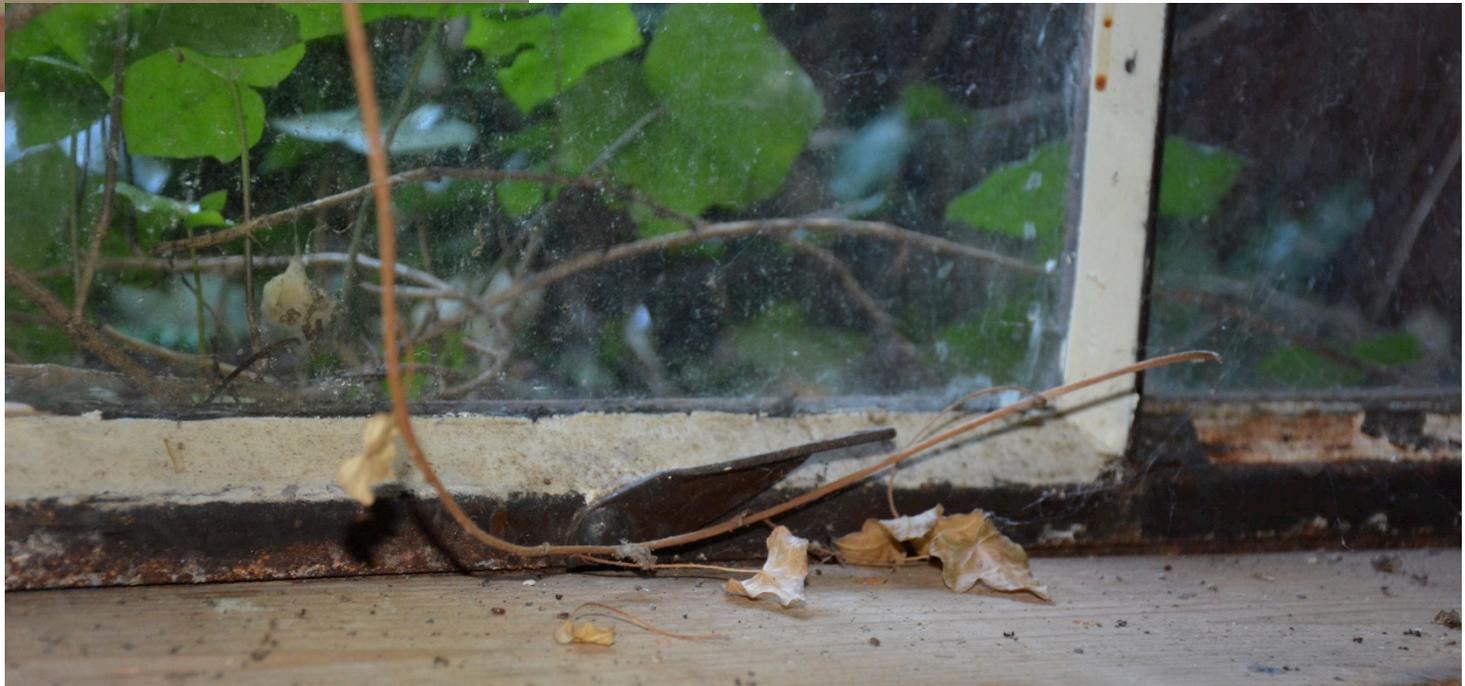
Window #4

Details
Major
degradation
lock rusted
shut

4&5- Existing Steel Window NOT visible by public right of way (below grade in window well) – to be replaced by glass block- preferred & recommended or Architect Awning Vent 38x20 (not preferred/recommended- wood product below grade)

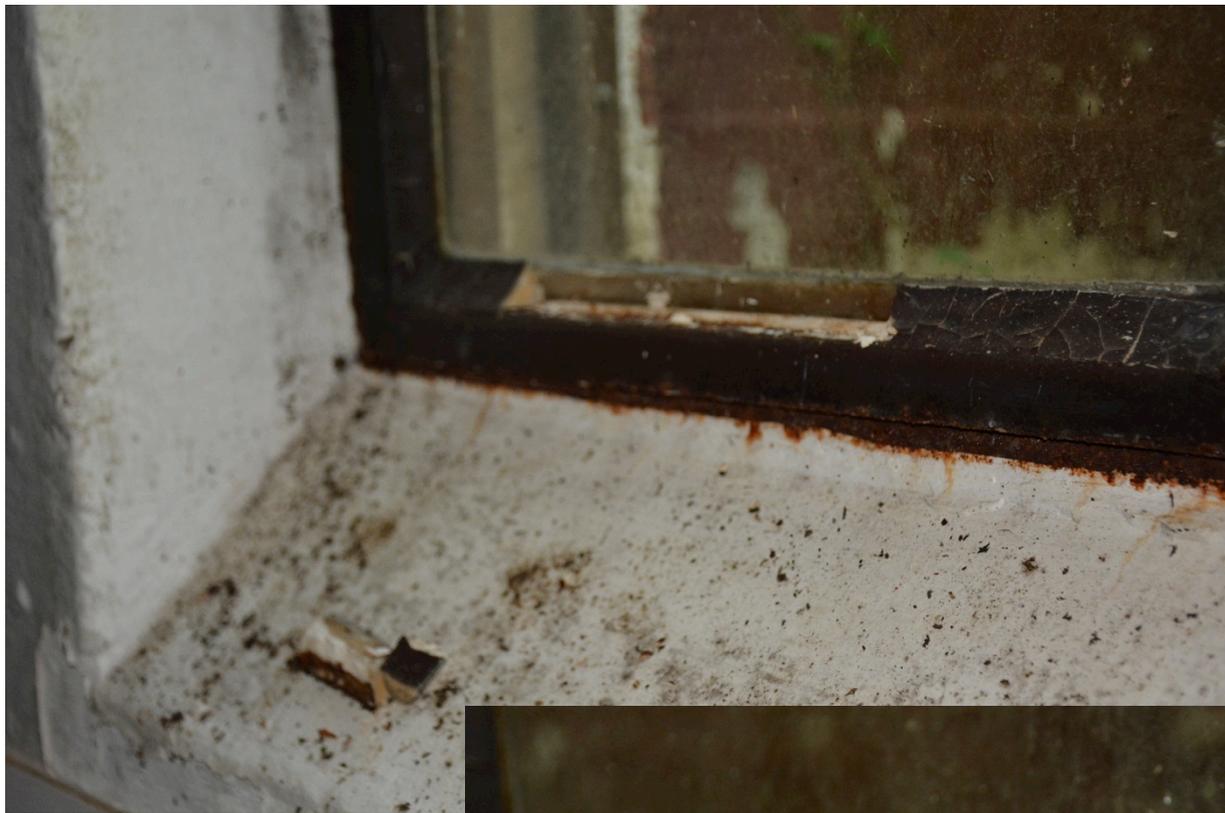
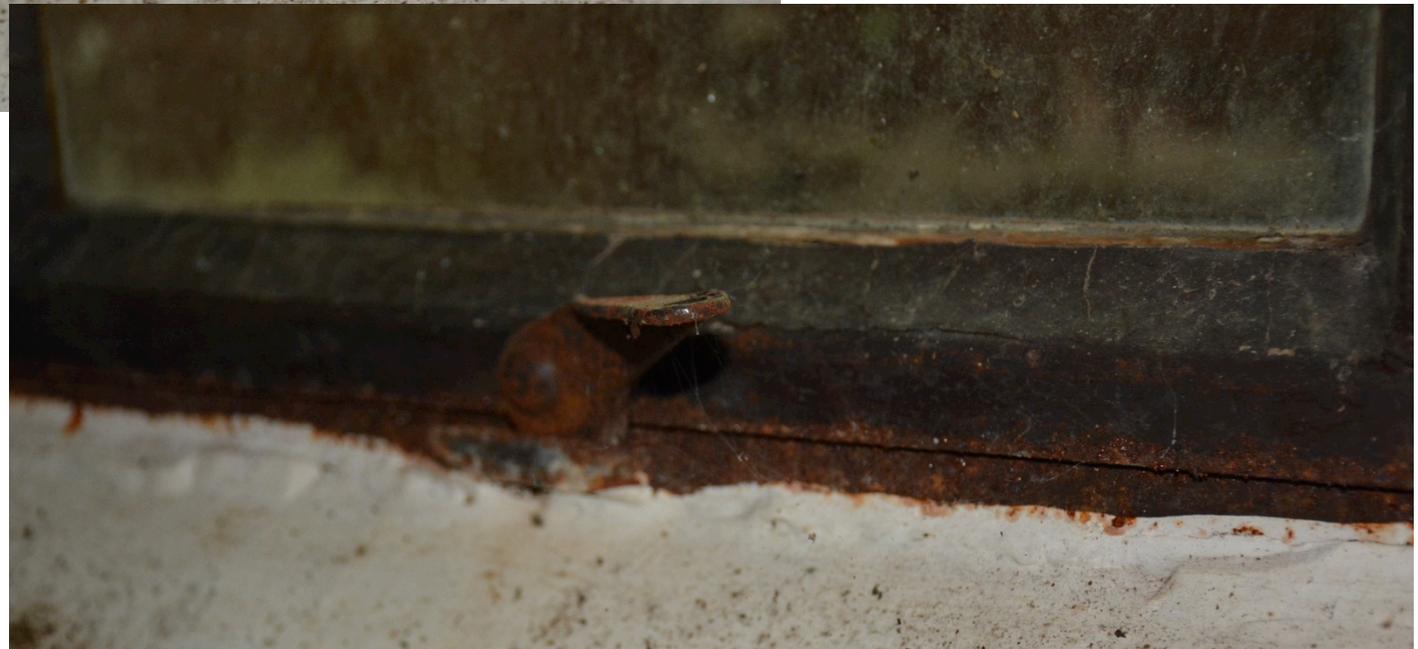
Window #5

Details
Major
degradation
lock rusted
shut

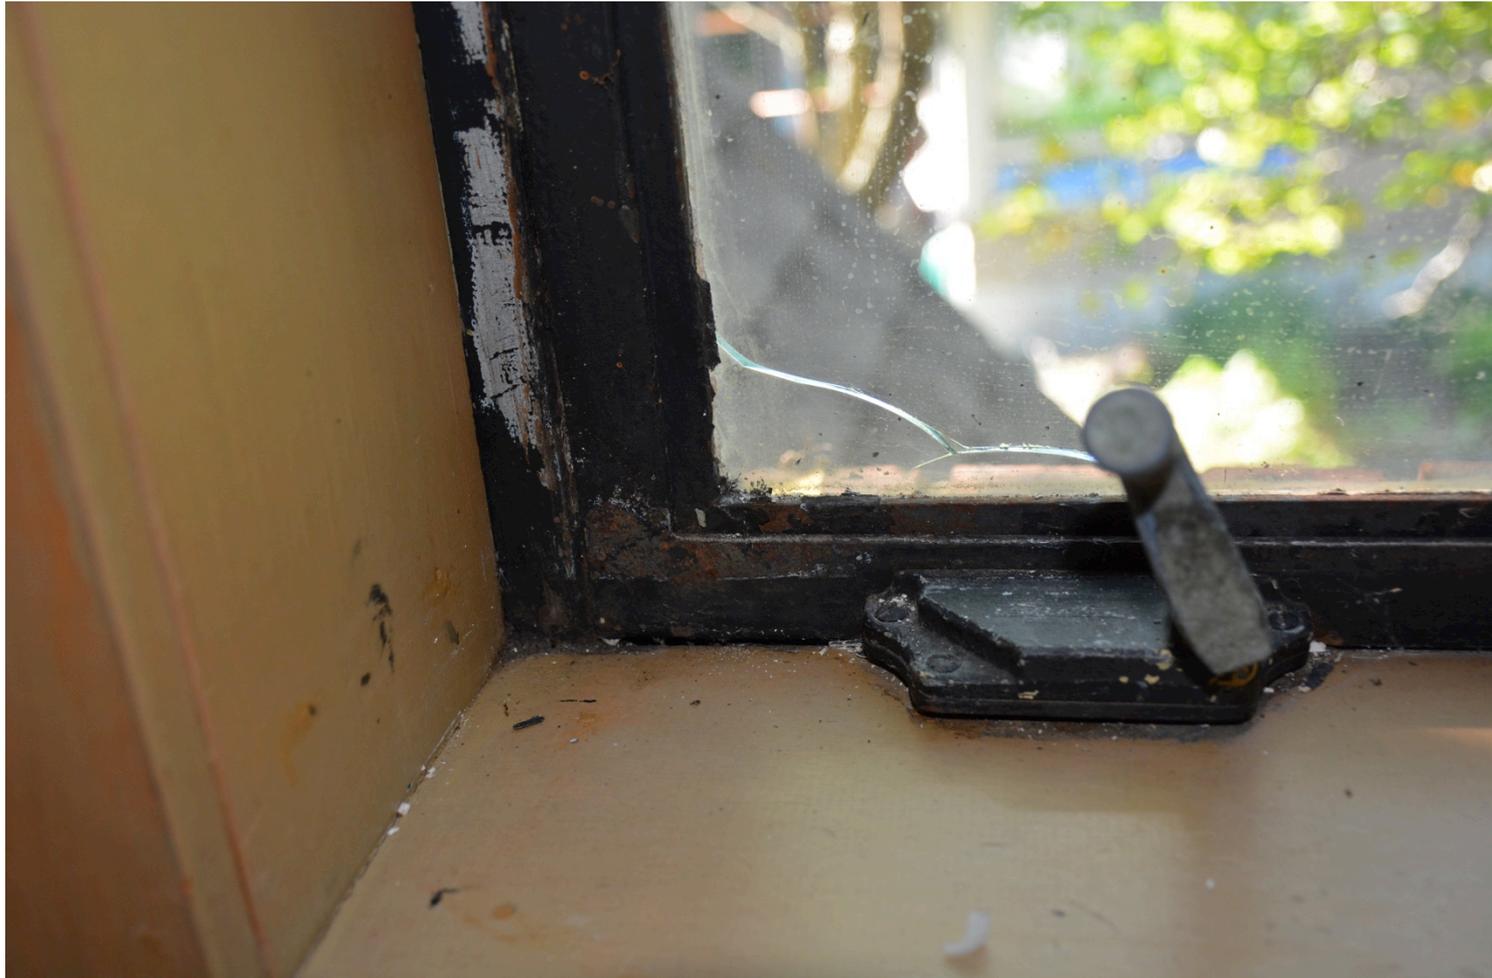
Window #6

Detail crack &
degradation

6&7- Existing Steel Window NOT visible by public right of way – to be replaced by Architect, Casement Left, 35x38
