AE REDEVELOPMENT

Asbestos Survey and Report

**West Lafayette City Hall
609 W Navajo Street
West Lafayette, IN 47906**

August 30, 2016

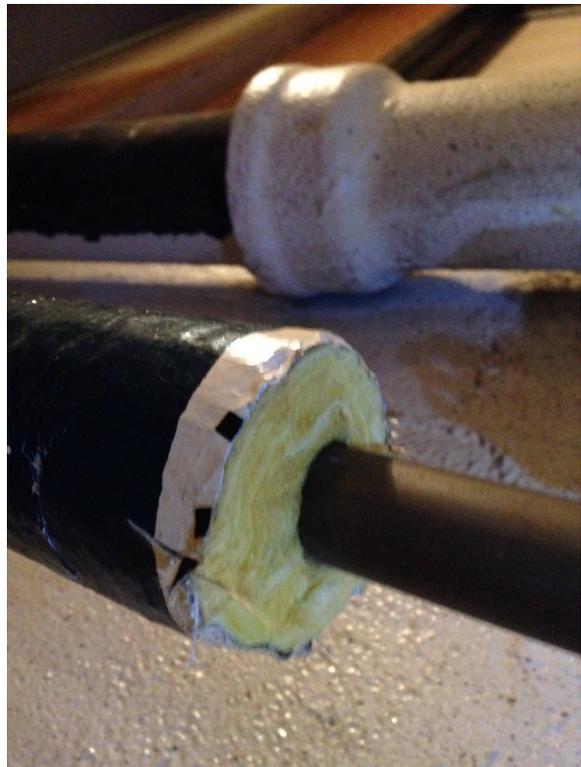
HA #19 – Thermal Insulation 01

The TSI has the highest asbestos content (15%) of the ACMs and is friable. This has the potential to present a significant health hazard to anyone entering the building. Thus, once abatement work has started, access to the building must be limited to licensed abatement workers in proper protective equipment only.
